FIG. 2. Cathode Profile Changes

Typical Axial Anode Erosion Profile, 3 Bp in 4 KHz ArF

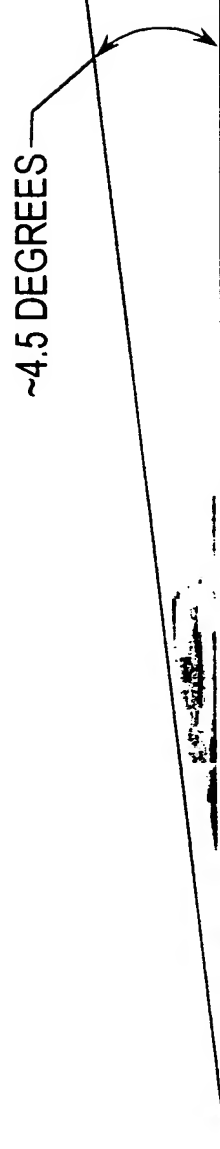
FIG. 25a

# ANODE SLOPE

(KrF, dual brass, ~ 7Bshots, C36 center, C26 body)

(Taken in non-reefed region)
